BREMER SCHOOL

1202-1220 Lowry Avenue North

1931

### DETAILED REPORT

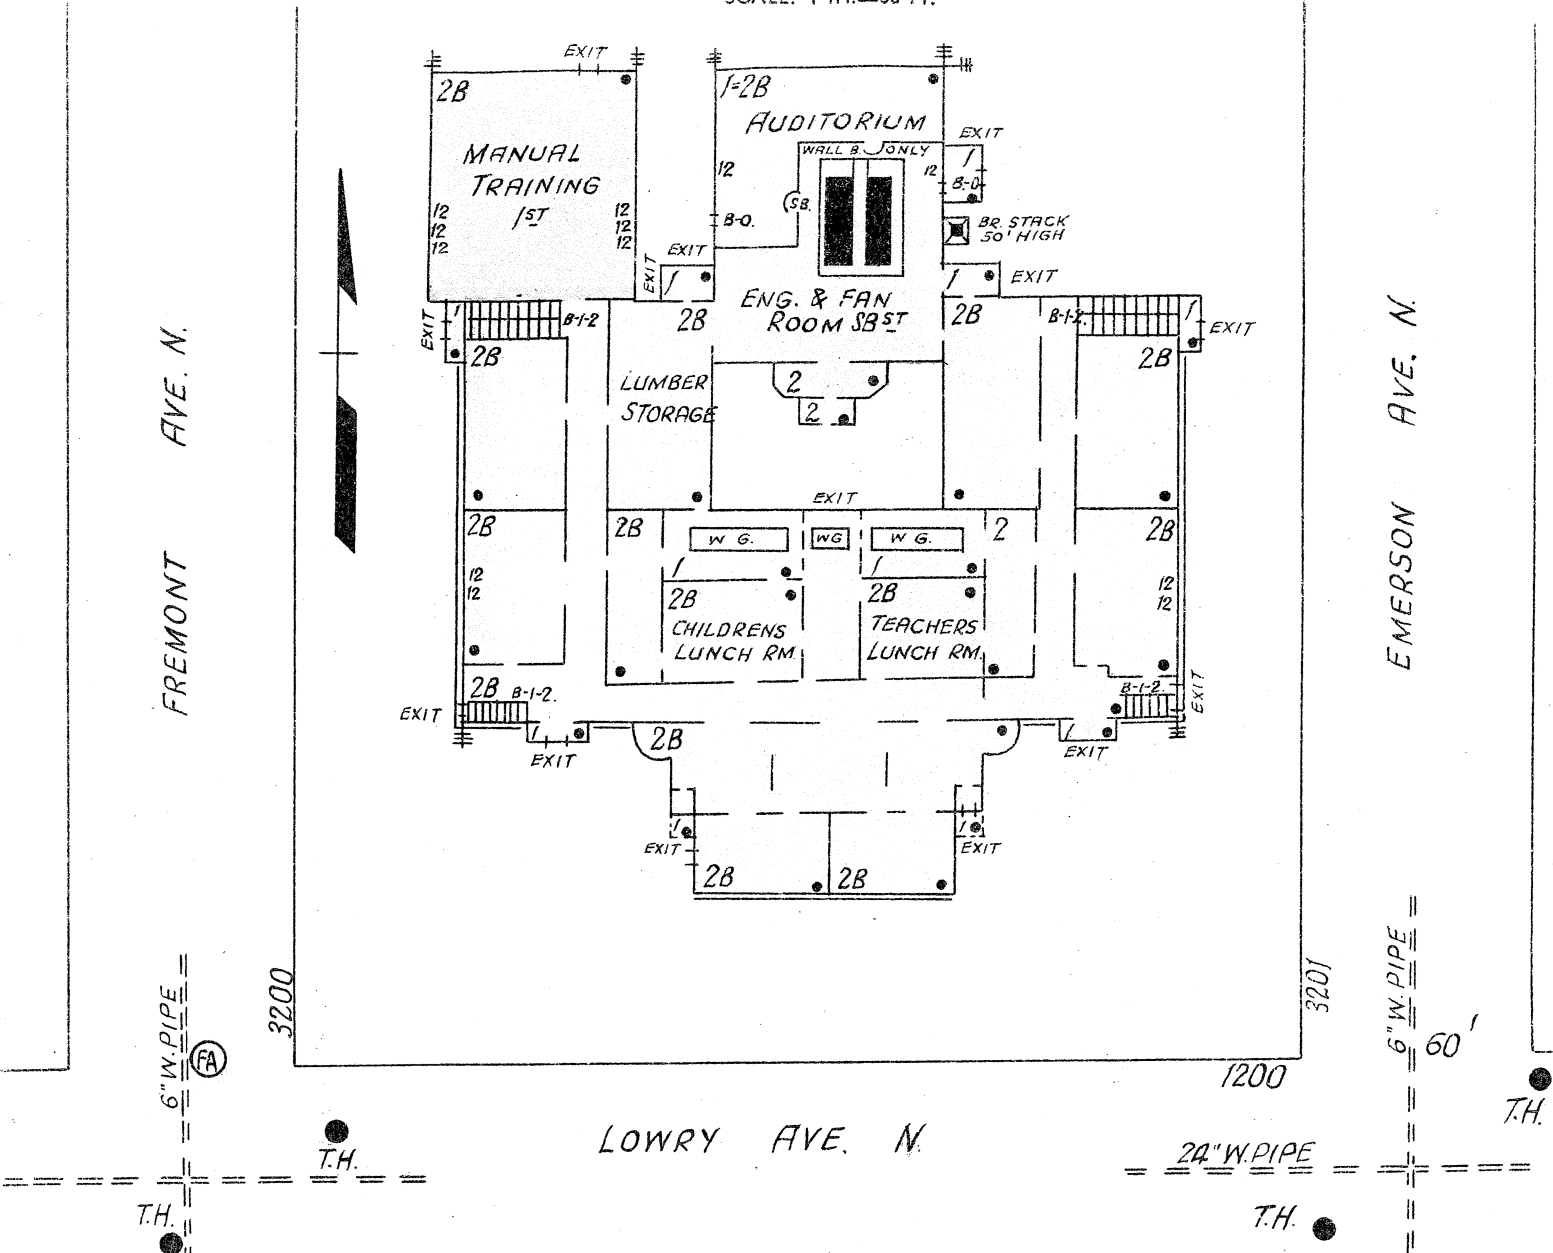
# BREMER SCHOOL

- ERECTED: 1887-1897-1910-1916.
- CONDITION: Fair.
- HEIGHT: 1-3 Stories.
- AREA: 23,000 each floor.
- FLOORS: Ordinary wood, old section; reinforced concrete in additions.
- ROOF: Composition on 7/8" boards on wood joists.
- FLOOR OPENINGS: Two open and two enclosed stairs, basement to first.
- OPENINGS: Four open stairs, first to second.

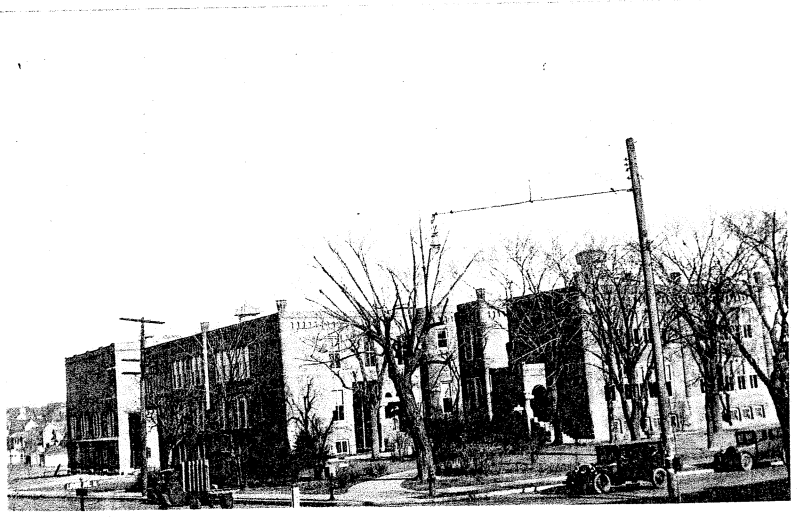
A three and two story structure with wood and concrete floors. Poor egress from basement in old section which is of quick burning construction.
