FULTON SCHOOL

Vincent Avenue S. and 49th Street W.

1931

DETAILED REPORT

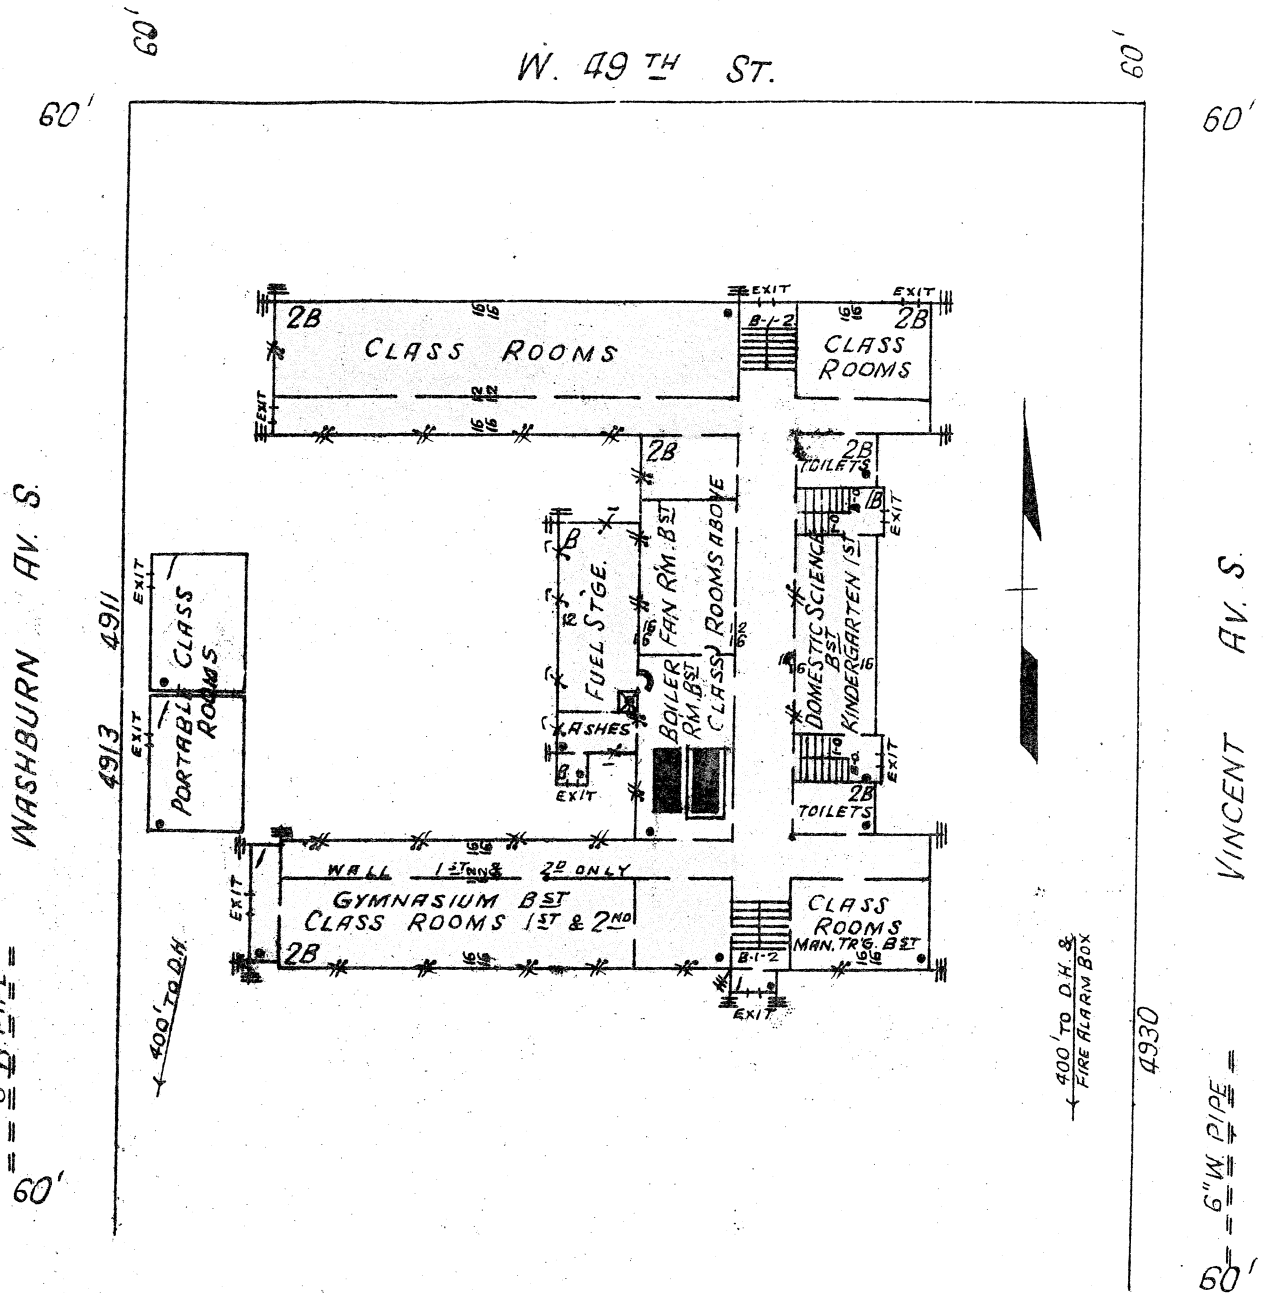
FULTON SCHOOL

ERECTED: 1915, 1922.
CONDITION: Good.
HEIGHT: One and two stories.
AREA: Bsm't. 19,426 sq. ft.; 1st 18,294 sq. ft.; 2nd 16,376 sq. ft.
WALLS: 16" brick and brick and tile.
FLOORS: Reinf. conc.
ROOF: Fireproof sections have ordinary wood joisted roof, gravel surfaced with reinf. conc. ceiling beneath, except boiler room and one story section which has reinf. conc. roof. Brick section has ordinary wood joisted roof, metal lath and plaster ceiling beneath.
FLOOR OPENINGS: Four open stairways bsm't. to 1st, two open stairways 1st to 2nd.
PORTABLES: Ordinary frame.
