HAWTHORNE SCHOOL
424 24th Avenue N.

HAWTHORNE SCHOOL

DETAILED REPORT

HAWTHORN SCHOOL

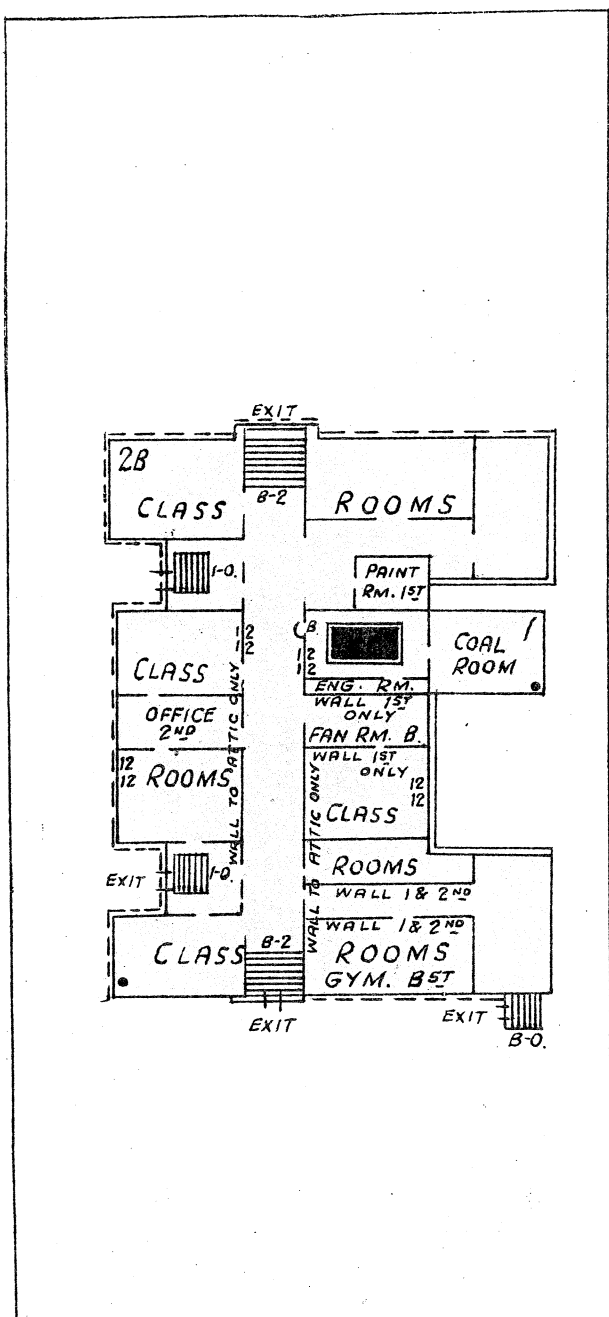
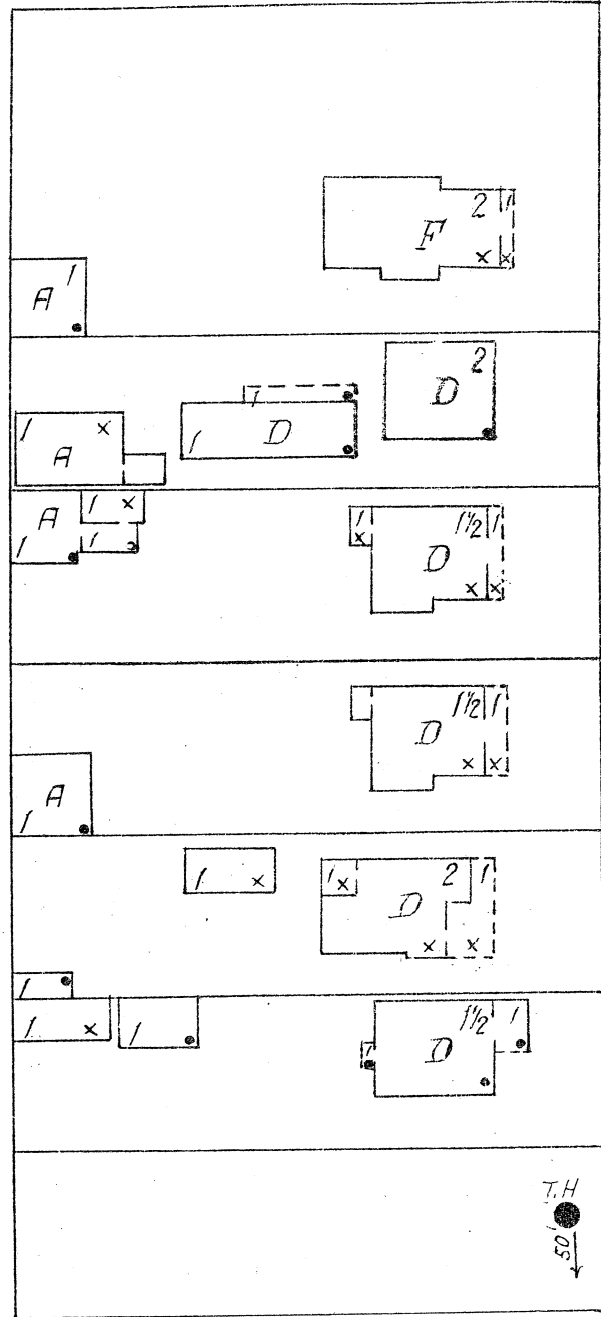
- ERECTED: 1883, 1903, 1912.
- CONDITION: Fair.
- HEIGHT: Two stories.
- AREA: Basement, first and second, 13,000 Sq. Ft.
- WALLS: 12" brick.
- FLOORS: Ordinary wood joist.
- ROOF: Slate roofing on wood boards on wood joists.
- FLOOR OPENINGS: Two open stairways, basement to second.
