SHERIDAN SCHOOL

Broadway and University Avenue N.E.

1931

DETAILED REPORT

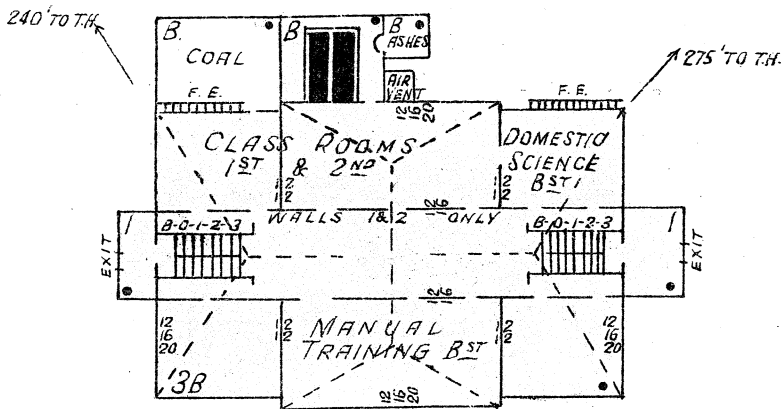
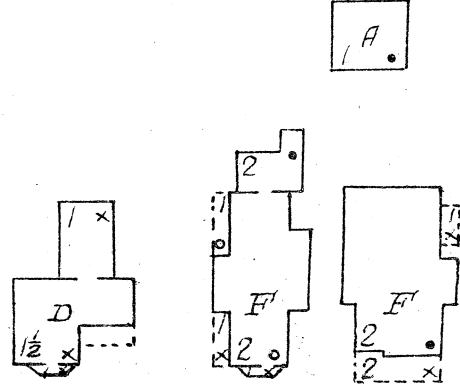
SHERIDAN SCHOOL

ERECTED	1896.
CONDITION	Fair to poor.
HEIGHT	One and three stories.
AREA	Bsmt., 10,900 sq. ft.; 1st, 9,975 sq. ft.; 2nd, 9,375 sq. ft.
WALLS	20, 16 and 12 in; brick joisted.
FLOORS	Ordinary wood joisted.
ROOF	Ordinary wood joisted with composition and metal surfacing.
FLOOR OPENINGS	Two open wood stairways from basement to 3rd floor.
