TRUDEAU SCHOOL

4th Street and 9th Avenue S. E.

1931

DETAILED REPORT

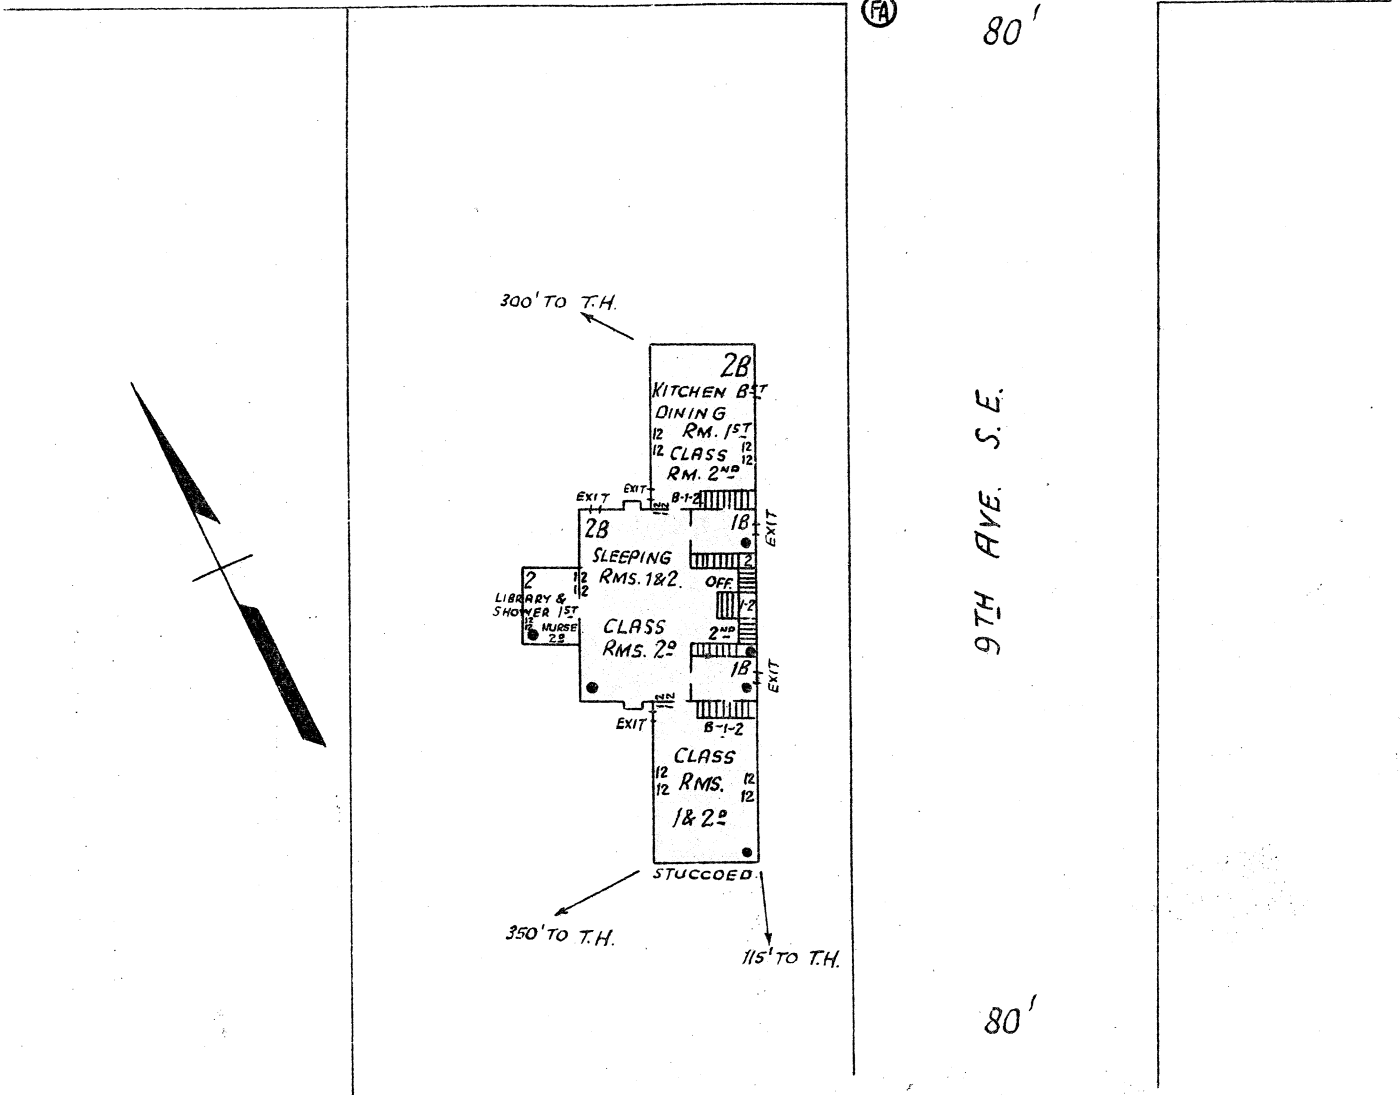
ERECTED: 1872.
CONDITION: Fair to poor.
HEIGHT: One and two stories.
AREA: Basement, 4,545 Sq. Ft.
 First, 4,845 Sq. Ft.
 Second, 4,440 Sq. Ft.
WALLS: 12" brick, stuccoed.
FLOORS: Ordinary wood joisted.
ROOF: Ordinary wood joisted, slate surfacing.
FLOOR OPENINGS: Two open stairways, basement to first and three open stairways, first to second floor.

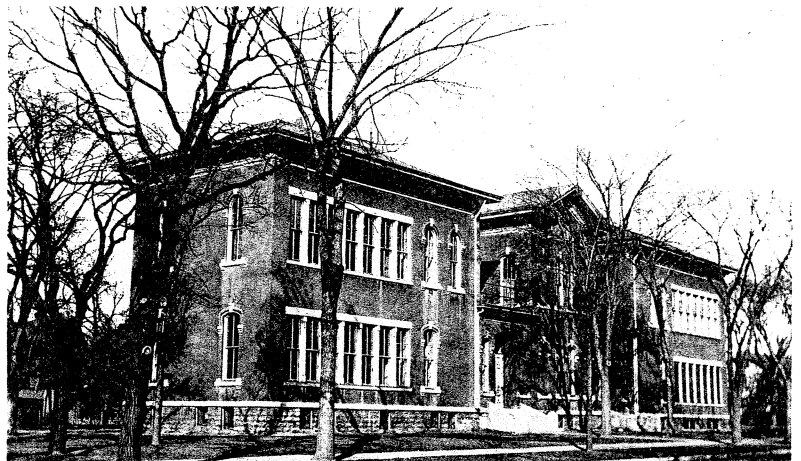
One of the oldest buildings with quick burning wood interior construction. Egress facilities are poor as stairways are narrow and poorly arranged. One of the rear exit doors was found locked at the time of this inspection.

1. Install sufficient chemical fire extinguishers.
2. Replace wood joisted floor over boiler room with fireproof floor and protect all openings to boiler room with approved automatic fire doors.
3. Completely cover door to roof space with metal and keep door locked.
4. Clean up roof space and close up unused ventilation flues.
5. Provide safe means of egress from second floor, preferably a smoke proof tower.
6. Keep all exit doors unlocked during school session.
7. Replace oversize fuses on branch lighting circuits with fuses of not over 10 ampere capacity.
