GREELEY SCHOOL

12th Avenue S. and E. 26th Street

1931

DETAILED REPORT

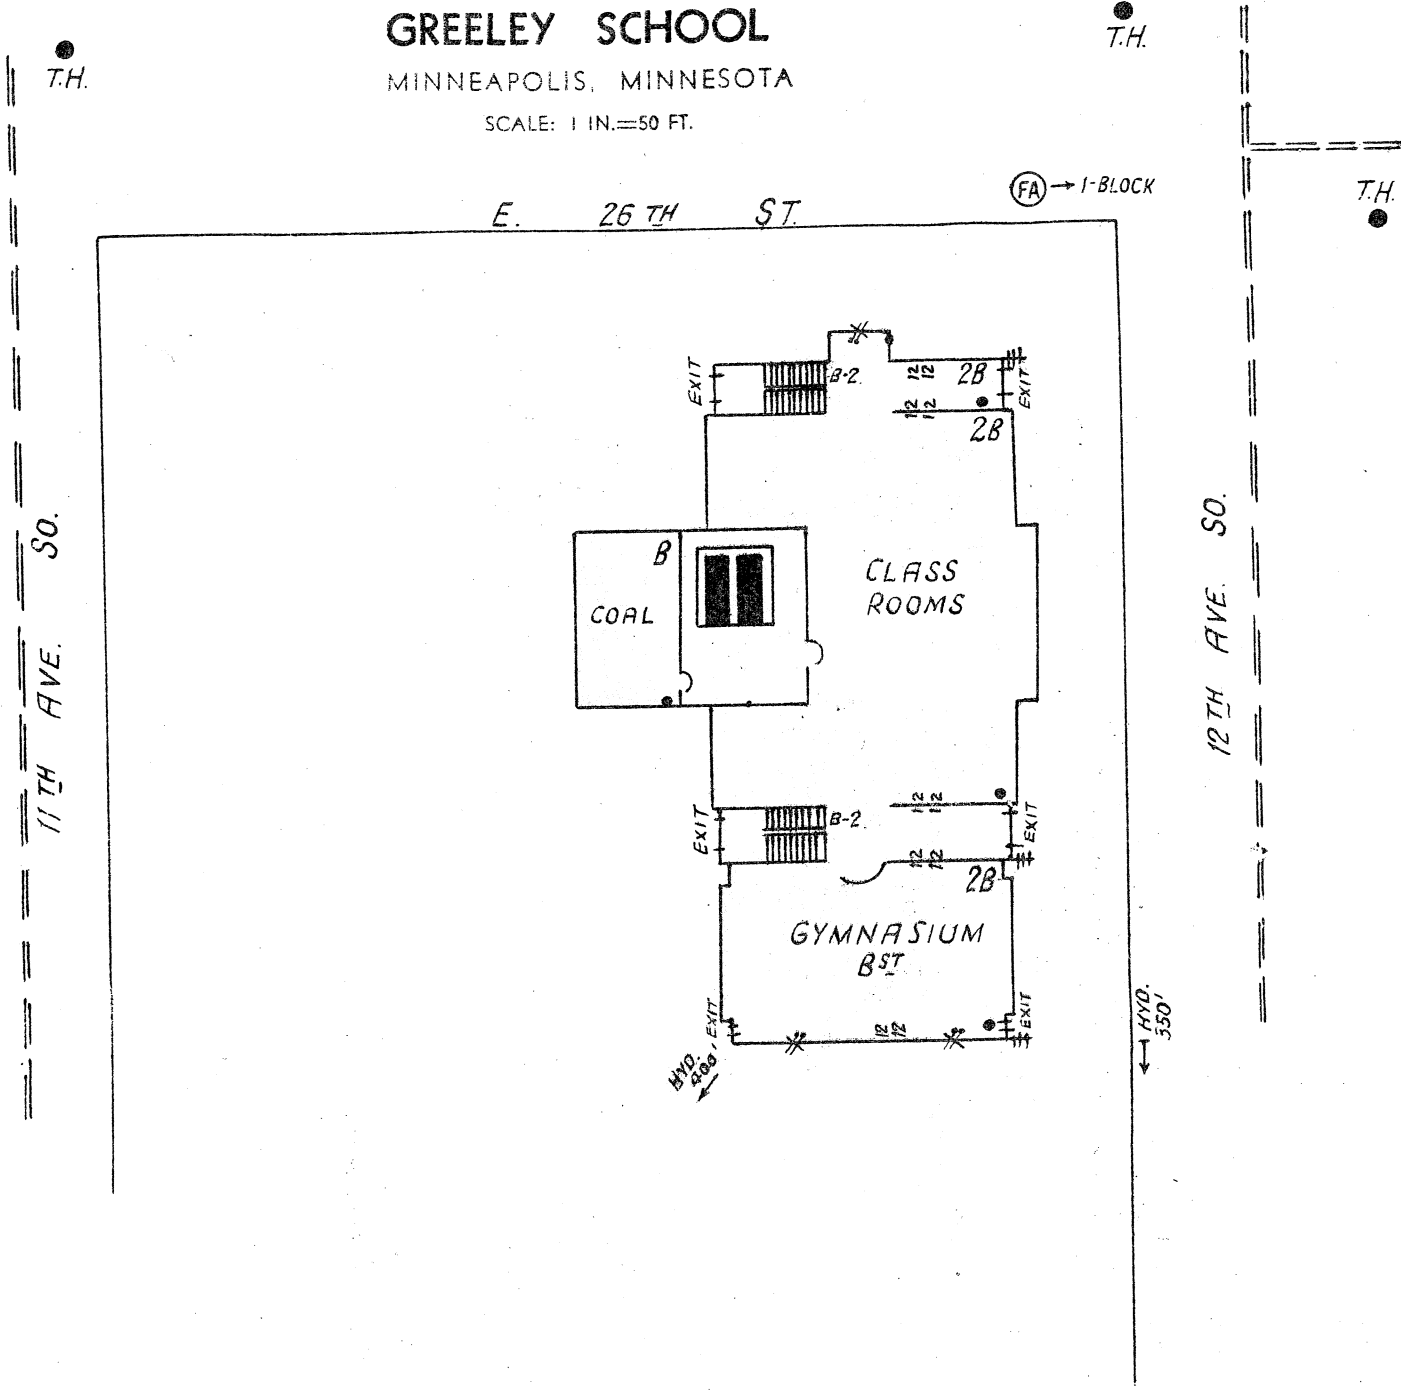
GREELEY SCHOOL

ERECTED: 1888 and 1912.
CONDITION: Fair.
HEIGHT: One and two stories.
AREA: Basement, 15,340 Sq. Ft., 1st and 2nd floors, 14,080 Sq. Ft. each.
WALLS: 12" brick.
FLOORS: Ordinary wood joisted.
ROOF: Wood joisted, composition surfaced.
FLOOR OPENINGS: Two open stairways, basement to 2nd. One, 2nd to attic.
