HAY SCHOOL

2112 OAK PARK AVENUE

1931

### DETAILED REPORT

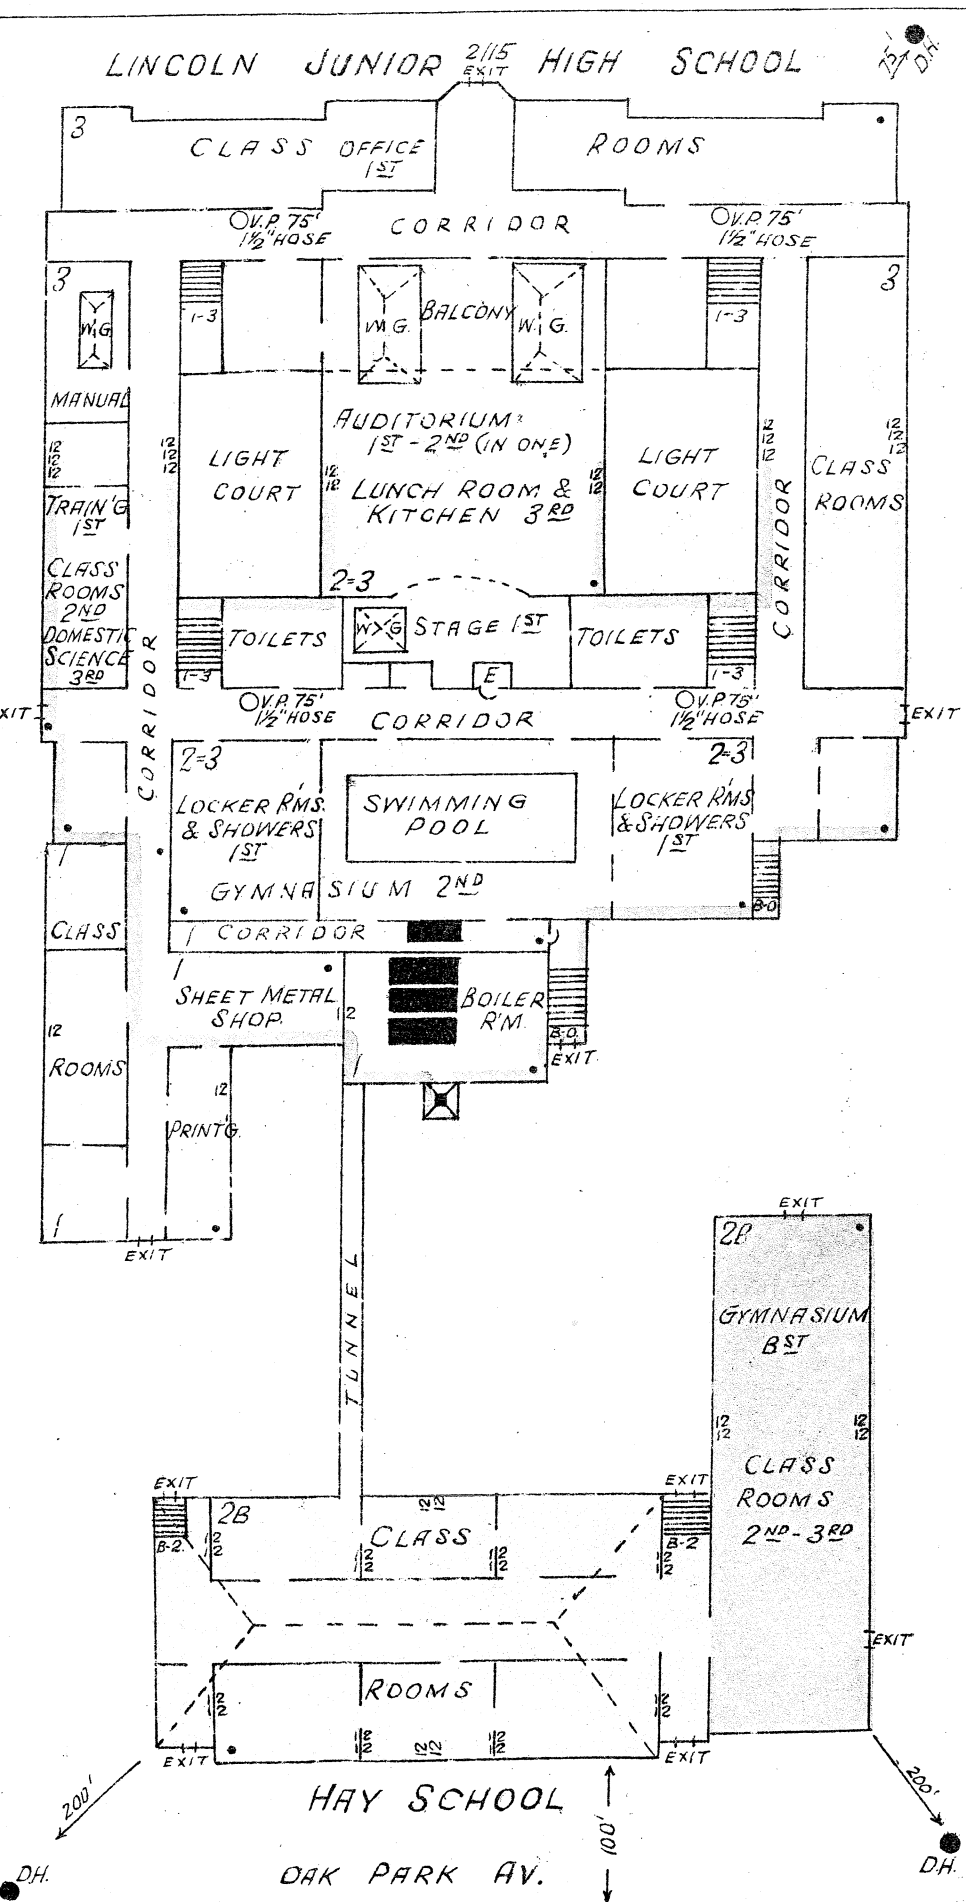
**HAY SCHOOL**  
 MINNEAPOLIS, MINNESOTA  
 SCALE: 1 IN. = 50 FT.

**ERECTED:** 1906-1925.  
**CONDITION:** Good.  
**HEIGHT:** Two stories.  
**AREA:** 15,450 sq. ft. bsf., 1st and 2nd.  
**WALLS:** 12" brick.  
**FLOORS:** Wood in old section, reinforced concrete new section.  
**ROOF:** Slate on wood old section, false roof on new section.  
**FLOOR OPENINGS:** Two open wood stairways, but none in new addition.
