PRESCOTT SCHOOL

Lowry Avenue and Taylor Street N.E.

1931

DETAILED REPORT

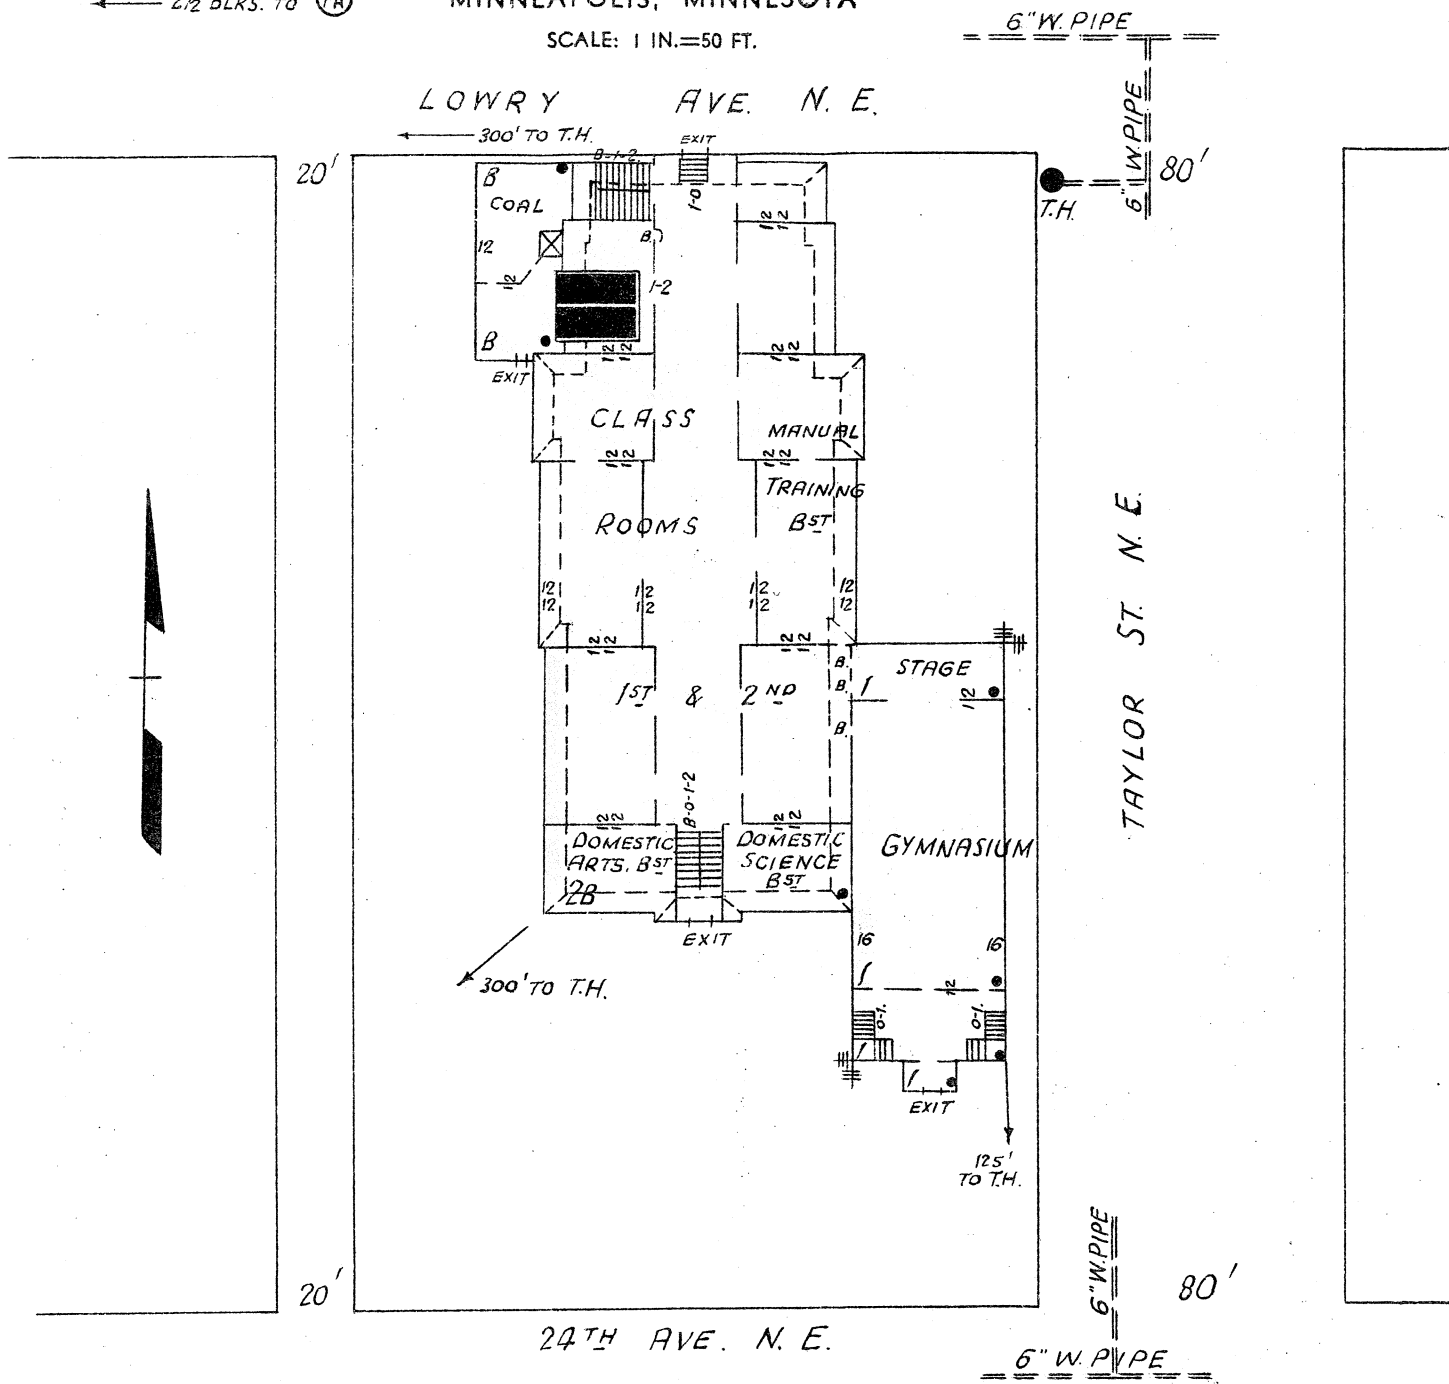
PRESCOTT SCHOOL

ERECTED	1884, 1901, 1909 and 1930.
CONDITION	Good.
HEIGHT	One and two stories.
AREA	Basement, 16,350 Sq. Ft. First, 19,600 Sq. Ft. Second 15,200 Sq. Ft.
WALLS	16" and 12" brick.
FLOORS	Ordinary wood joisted.
ROOF	Ordinary wood joisted with composition surfacing.
FLOOR OPENINGS	Two open stairways from basement to second floor.
