EMERSON SCHOOL

Spruce Place and 14th Street W.

1931

DETAILED RPEORT

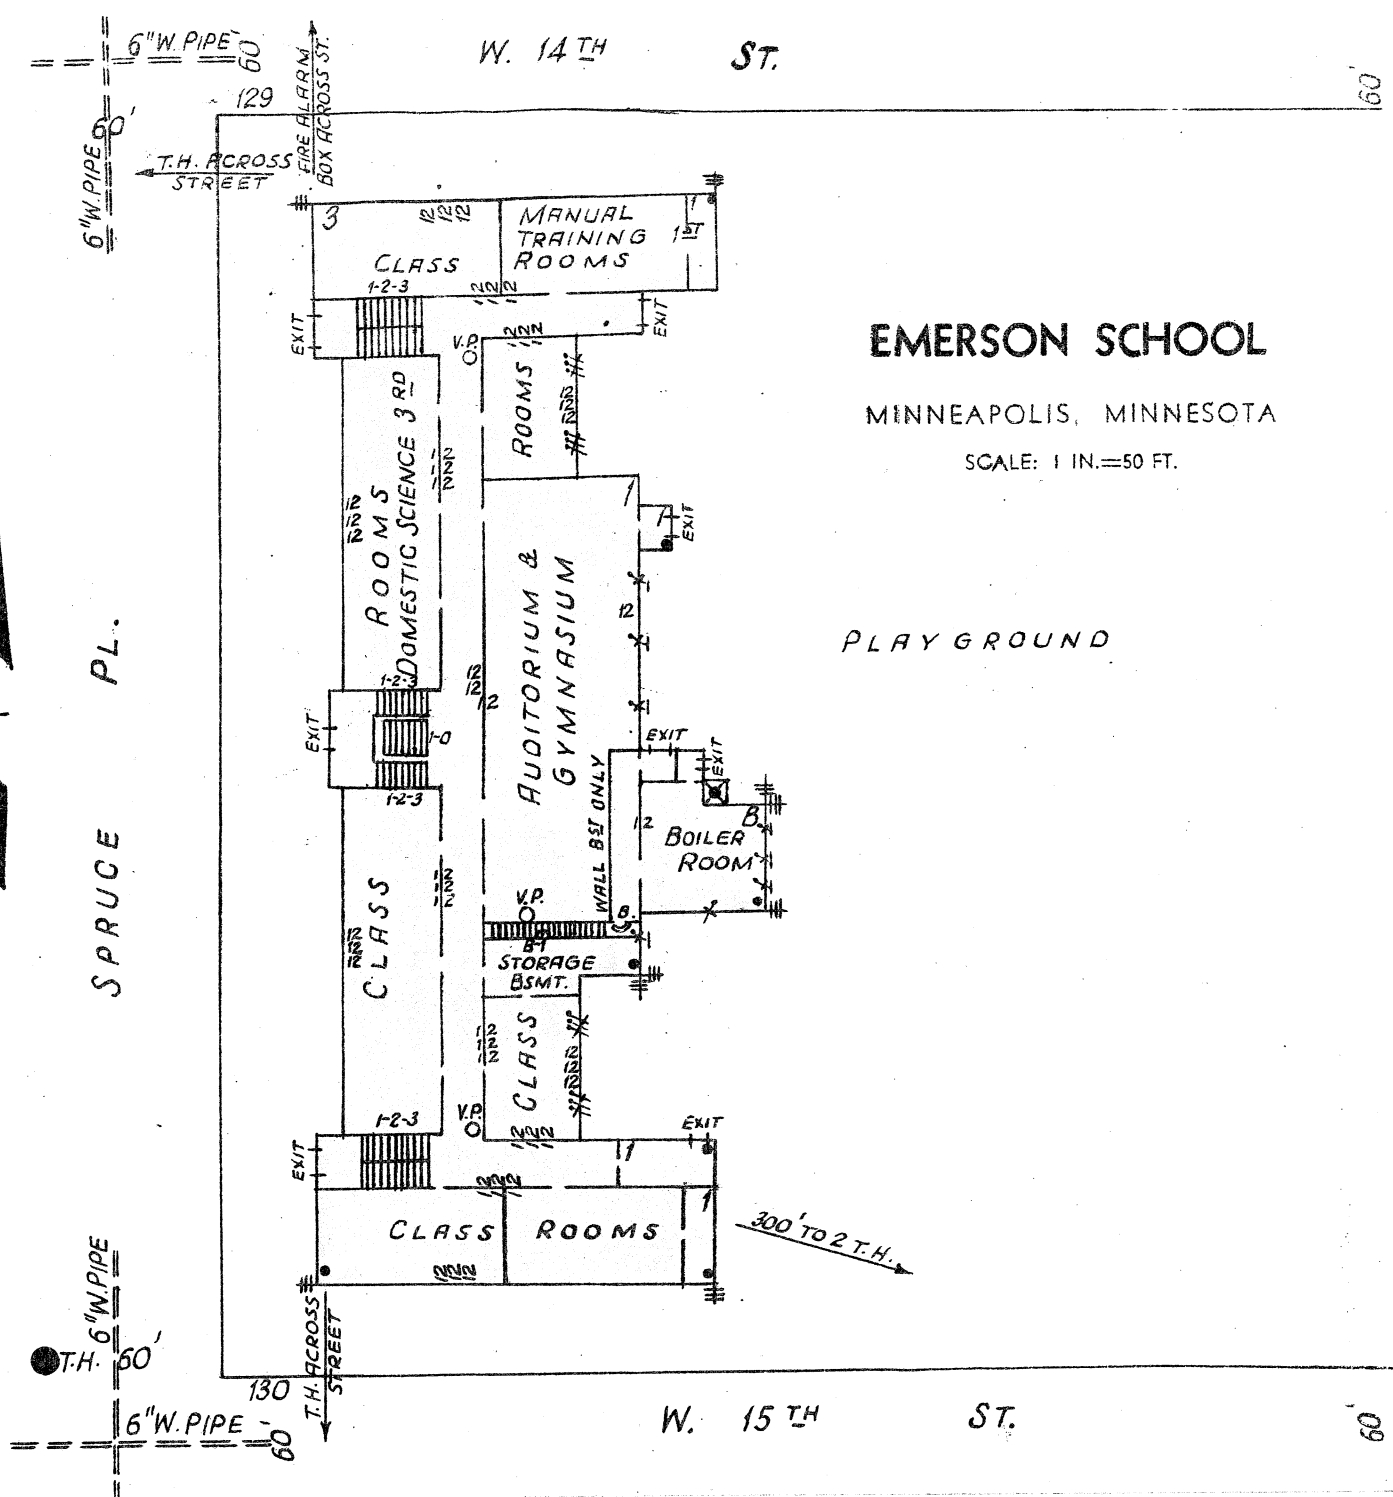
EMERSON SCHOOL

EGRESS FACILITIES: According to the exit code, the means of egress from this building are adequate. The open stairways, however, detract from this adequacy due to the possibility of blocking by smoke or fire.

FIRST AID PROTECTION: Standpipes and hose are provided to adequately protect all sections of building. Insufficient number of chemical fire extinguishers.

ERECTED: 1926.
CONDITION: Excellent.
HEIGHT: One and three stories.
AREA: 1,734 Sq. Ft. Bst., 21,826 Sq. Ft. 1st, 16,600 Sq. Ft. 2nd and 3rd.
WALLS: Reinforced concrete frame with 12" brick and tile panel walls.
FLOORS: 9-12" reinforced concrete slab.
ROOF: Ordinary wood joisted with reinforced concrete slab ceiling beneath.
FLOOR OPENINGS: Three open stairways, 1st to 2nd to 3rd floors.

1. Install sufficient number of chemcial fire extinguishers.
