SHERIDAN SCHOOL

Broadway and University Avenue N.E.

1931

DETAILED REPORT

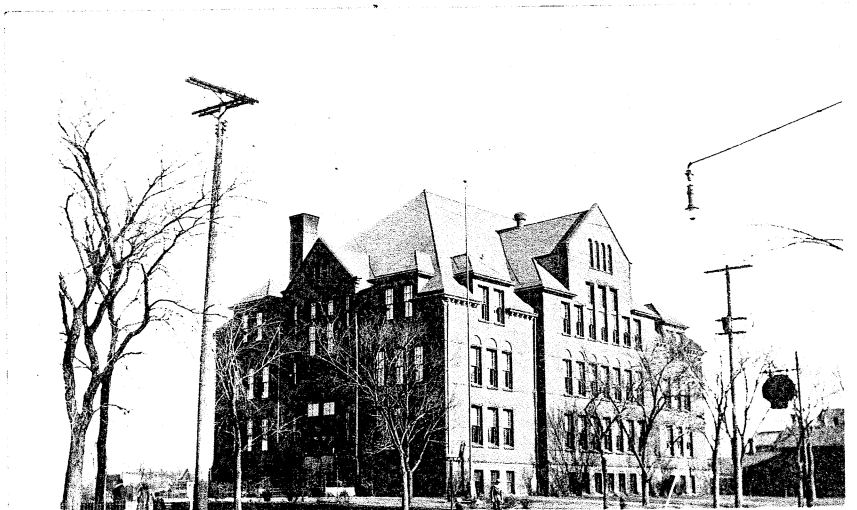
ERECTED	1896.
CONDITION	Fair to poor.
HEIGHT	One and three stories.
AREA	Bsmt., 10,900 sq. ft.; 1st, 9,975 sq. ft.; 2nd, 9,375 sq. ft.
WALLS	20, 16 and 12 in; brick joisted.
FLOORS	Ordinary wood joisted.
ROOF	Ordinary wood joisted with composition and metal surfacing.
FLOOR OPENINGS	Two open wood stairways from basement to 3rd floor.
