DOUGLAS SCHOOL

Franklin and Dupont Avenues S.

1931

DETAILED REPORT

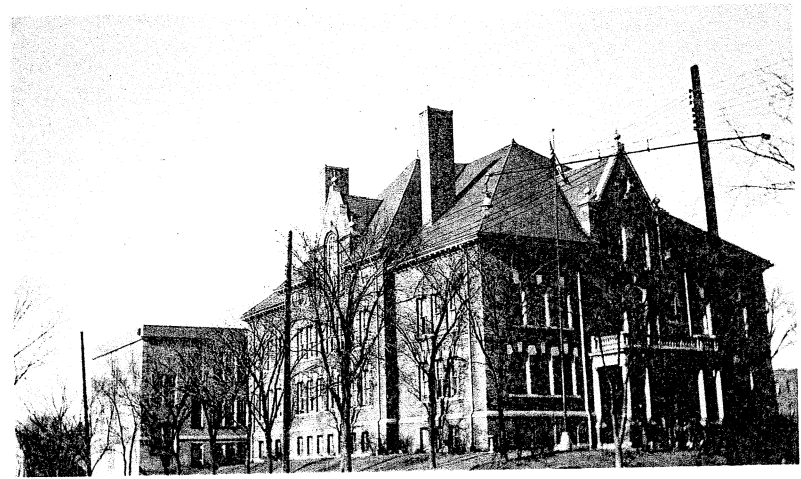
- BRICK BUILDING**
- ERECTED: 1894.
- CONDITION: Fair.
- HEIGHT: Three stories.
- AREA: Basement, 10,756 Sq. Ft.
First, second and third, 9,796 Sq. Ft.
- WALLS: 16" brick.
- FLOORS: Ordinary wood joisted.
- ROOF: Ordinary wood joisted, slate surfaced.
- FLOOR OPENINGS: Two open stairways, basement to first, to second, to third.
- FIREPROOF BUILDING**
- ERECTED: 1923.
- CONDITION: Good.
- HEIGHT: Two stories.
- AREA: 7,224 Sq. Ft.
- WALLS: Basement, first and second, 12" brick and tile panel walls.
- FLOORS: Reinforced concrete joist and tile.
- ROOF: Ordinary wood joisted, gravel surfacing.
- FLOOR OPENINGS: One open stairway, basement to first to second.
