GREELEY SCHOOL

12th Avenue S. and E. 26th Street

1931

DETAILED REPORT

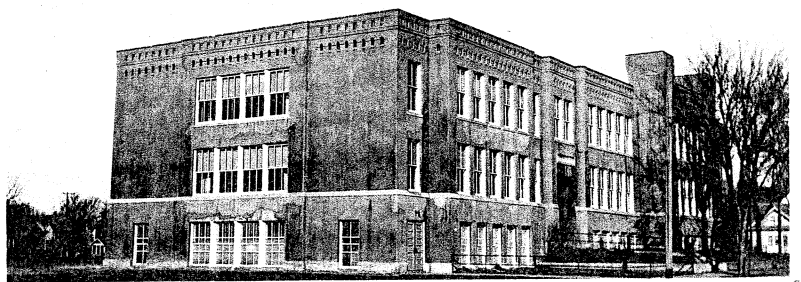
ERECTED: 1888 and 1912.
CONDITION: Fair.
HEIGHT: One and two stories.
AREA: Basement, 15,340 Sq. Ft., 1st and 2nd floors, 14,080 Sq. Ft. each.
WALLS: 12" brick.
FLOORS: Ordinary wood joisted.
ROOF: Wood joisted, composition surfaced.
FLOOR OPENINGS: Two open stairways, basement to 2nd. One, 2nd to attic.
