PRESCOTT SCHOOL

Lowry Avenue and Taylor Street N.E.

1931

DETAILED REPORT

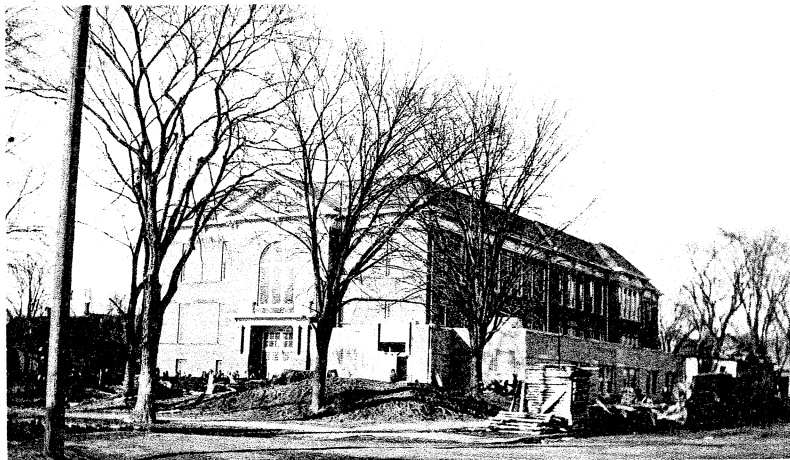
ERECTED	1884, 1901, 1909 and 1930.
CONDITION	Good.
HEIGHT	One and two stories.
AREA	Basement, 16,350 Sq. Ft. First, 19,600 Sq. Ft. Second 15,200 Sq. Ft.
WALLS	16" and 12" brick.
FLOORS	Ordinary wood joisted.
ROOF	Ordinary wood joisted with composition surfacing.
FLOOR OPENINGS	Two open stairways from basement to second floor.
