JORDAN JUNIOR HIGH SCHOOL

The Charles M. Jordan High School, erected in 1922 is a two-story masonry and wood structure. It has a basement. It is located on a 4.8 acre site at 2927 Irving Avenue North.

SCHOOL BUILDING FACT SHEET

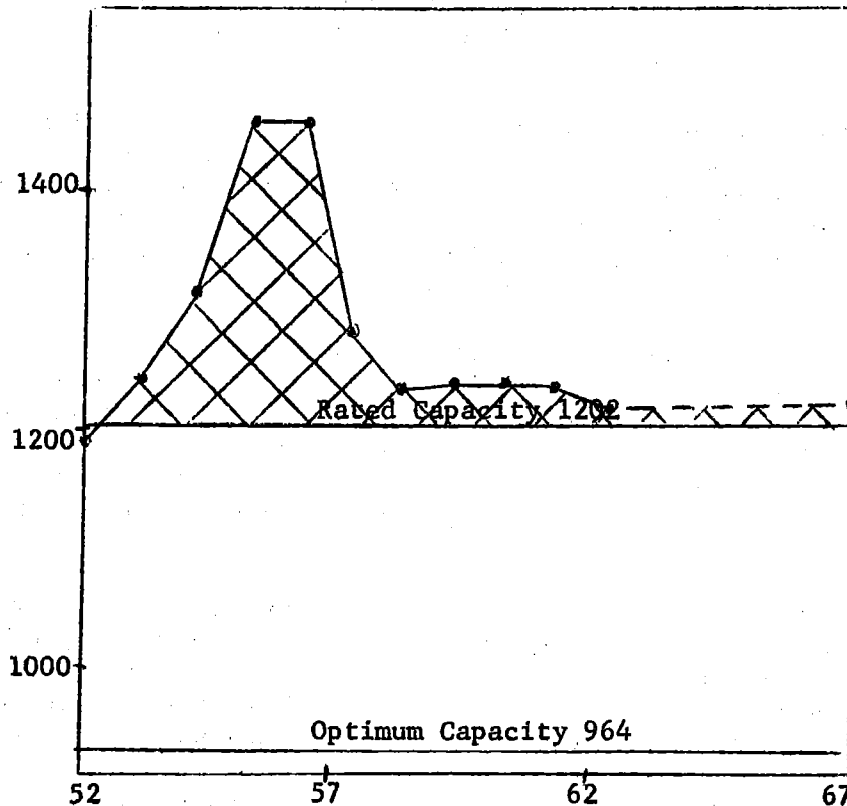
ENROLLMENT

ENROLLMENT TREND

Year	Sept.
1952	1198
1953	1225
1954	1320
1955	1428
1956	1428
1957	1294
1958	1267
1959	1268
1960	1268
1961	1268
1962	1249
1967 ²	1243
