ALCOTT SCHOOL

St. Louis Avenue and W. 29th Street

1931

DETAILED REPORT

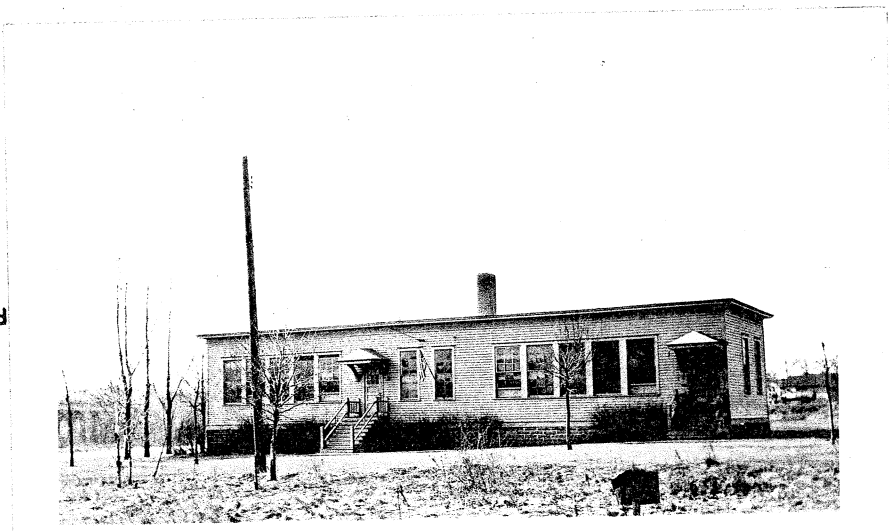
ALCOTT SCHOOL

6" W. PIPE (DEAD ENDED)

6" W. PIPE == W. 29TH ST.

1/2 BLOCKS TO FIRE ALARM BOX
350' TO D.H.
250' TO D.H.

ST. LOUIS AVE.

D.H.

6" W. PIPE

ERECTED: 1921.
CONDITION: Good.
HEIGHT: One story
AREA: 2,360 Sq. Ft.
WALLS: Frame.
FLOORS: Ordinary wood joisted.
ROOF: Ordinary wood joisted, metal and composition surfacing.
FLOOR OPENINGS: None.
